'They're all like that, sir'

Roger King uncovers more surprises in his latest XK 140 update – some of which were courtesy of Jaguar itself

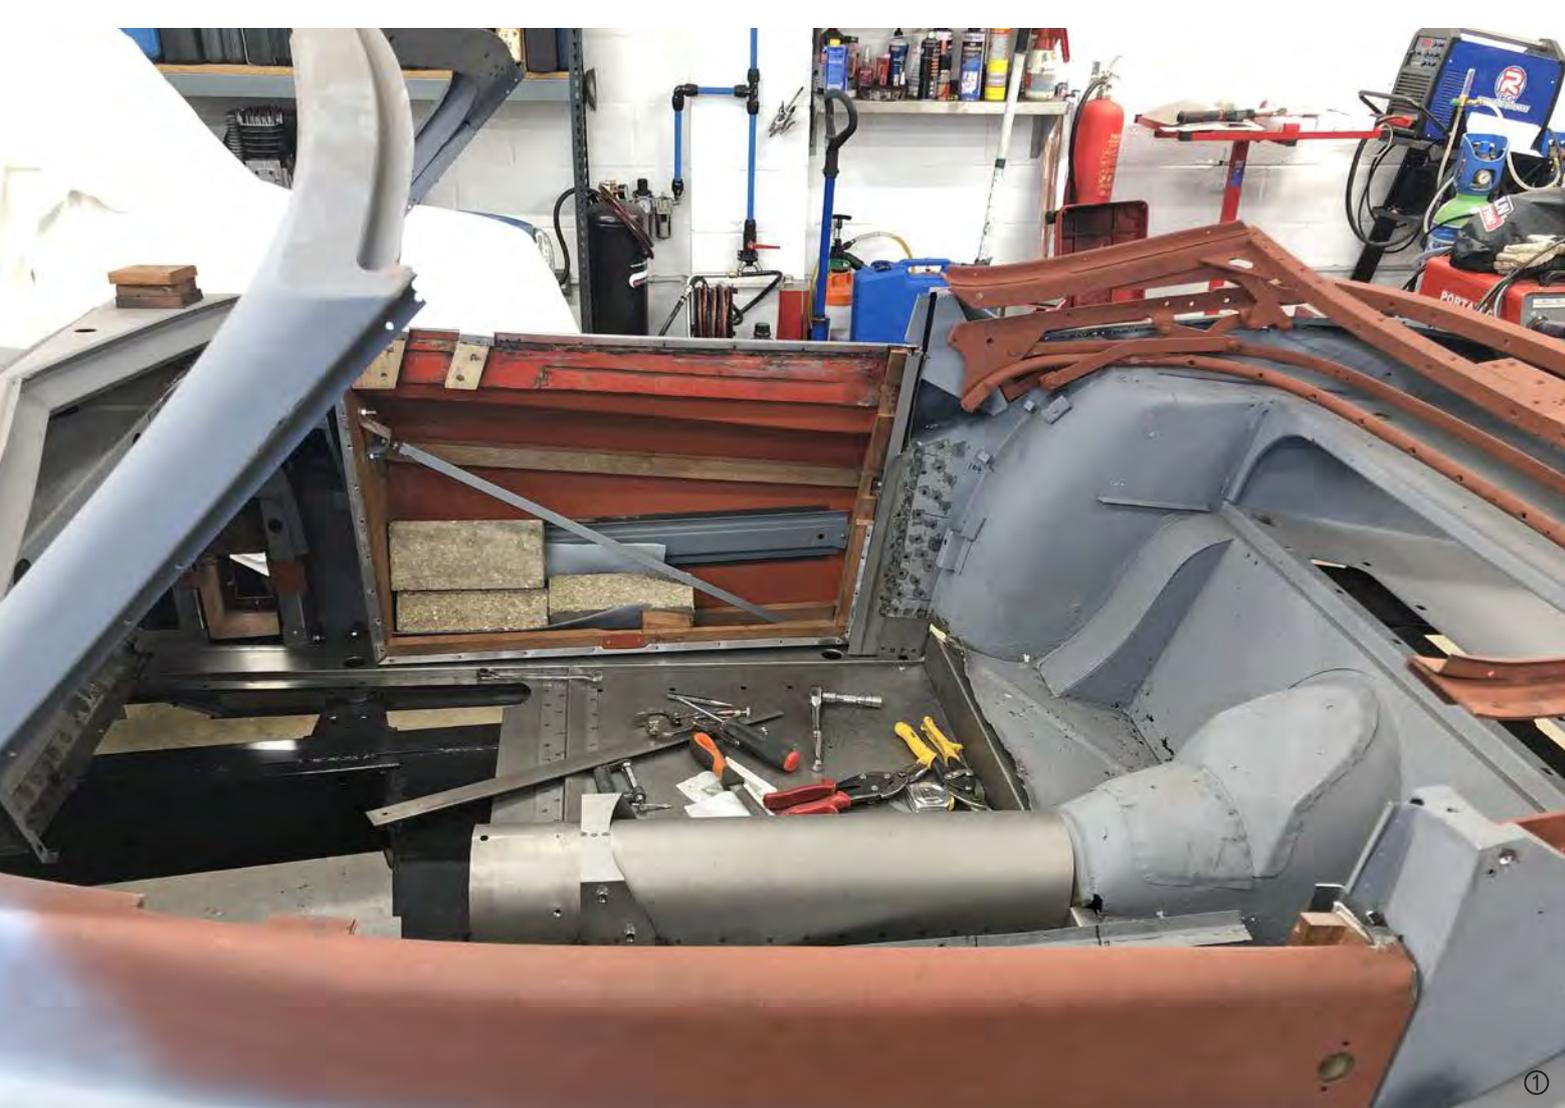
①

Photo one shows three concrete house bricks nestling in the right-hand door shell of my car. There is a reason for this. The door of an XK 140 drophead coupé comprises a hardwood frame, a steel door skin, a brass quarterlight frame, a vent glass, two glass tracks, a winder quadrant, a door latch mechanism and last, but by no means least, a heavy drop glass. This all adds up to a pretty hefty component that, due to its weight, is quite capable of changing the way the door shell fits into the hole in the side of the car. This can be even more pronounced if the flimsy original hinges and their bracketry are still installed.

The best way to allow for this extra loading when making bodywork repairs is to weight the empty door to compensate before aligning

it – and having ‘borrowed’ the bathroom scales, I had worked out that three concrete bricks gave a pretty good weight approximation of all that aforementioned internal gubbins.

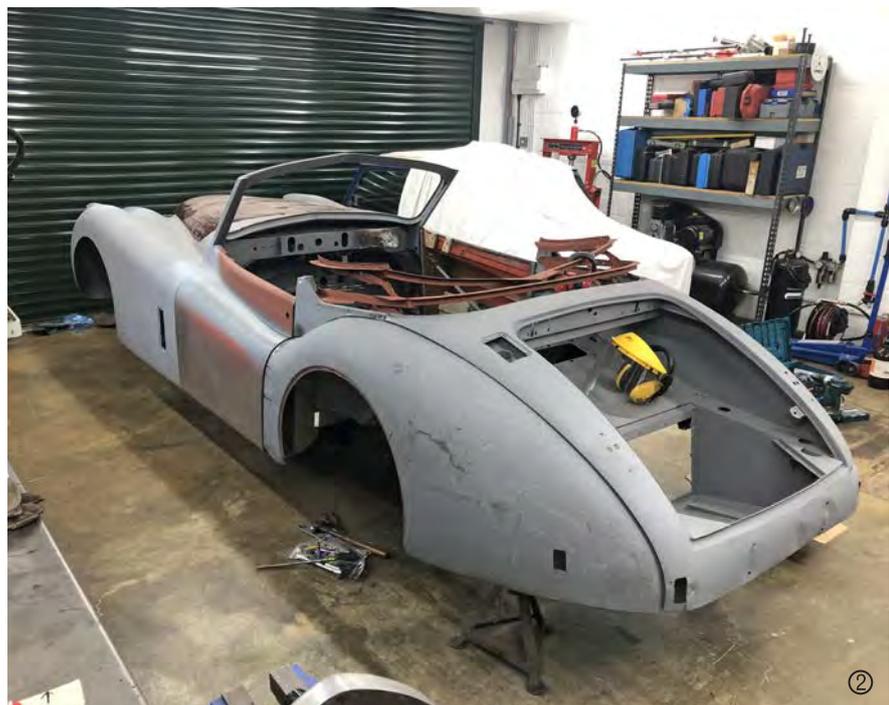
②

With the doors suitably weighted, I was now pretty happy with the general alignment (photo two). Now to get the floor sorted.

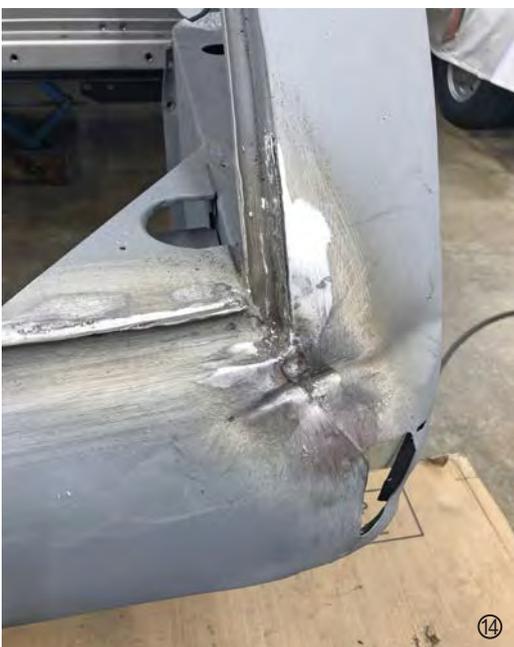
Photo 14 shows what was lying under the lead loading in the lower right corner, where the rear valance meets the tonneau panel. I had removed the battered lead work with a propane torch, and wire-brushed out the molten lead. The car had obviously been hit in this rear quarter, and more investigation of the rear valance pointed to further damage all the way along the rear of the bodywork below the boot lid.

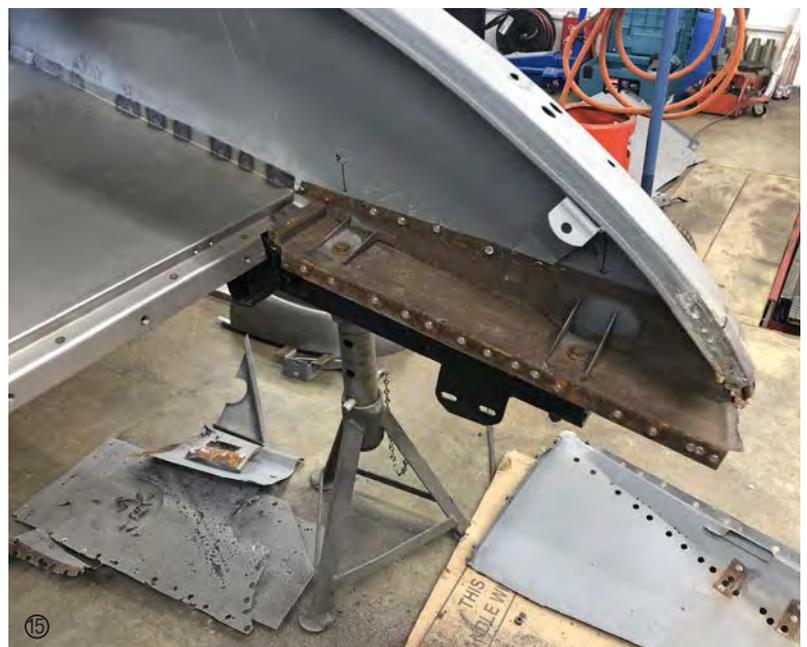
There was also rust in many of the internal panels (photo 15), where the blaster had been unable to reach the closed box sections. The operating theatre was put on high alert, and more drastic surgery than that originally contemplated was put into action.
