# From container to concours

**Ron Reeve** explains how he went about restoring his XK 140 drophead coupé

# Jaguar XK140 DHC 1955

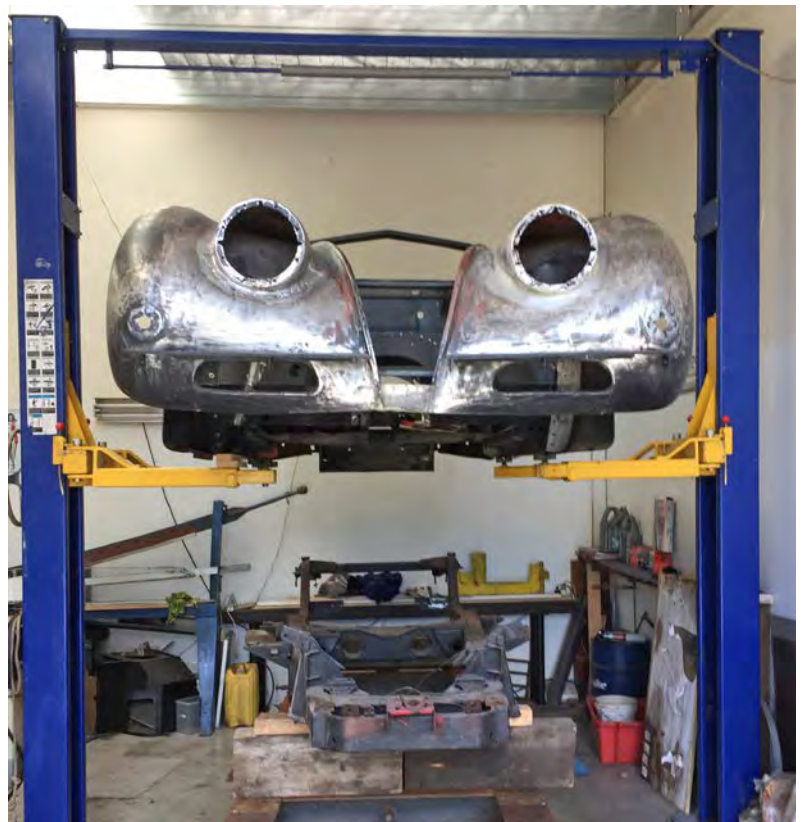
- Left: loading up the XK ready for the journey home and the restoration process to begin
- Bottom left: the decision was made to lift the body off the chassis, after first making some careful notes...
- Right: getting to work on the interior. The woodwork was refurbished by a specialist in Hamilton

After due consideration the next big decision was made – the removal of the body from the chassis and to do a detailed rebuild of each. While taking the body off the chassis is not a huge task, it is complicated in that during production there are differing thicknesses of round aluminium spacers and red fibre washers located at the chassis-to-body mounting points. This is done to ensure the correct fit of the doors, bonnet and boot lid and

means that the car sits straight and square on the chassis and everything is aligned. Patience is needed to record and document the various thicknesses at the specific locations to ensure a more efficient chassis-body marriage during future assembly.

Next on the agenda was the interior woodwork, a lovely feature of the drophead and fixed-head coupé models, with a beautiful gloss walnut veneer finish. The original wood was OK but certainly not up to a concours standard. The choice here was simple. We had used a specialist in Hamilton to do our other 140 woodwork so, after a phone call, the woodwork was sent to Hamilton for the same expert attention. The old veneer is removed, the wood prepared, and new veneer applied using specialist tooling. This is followed by applying multiple coats of the gloss finish and lots of hand finishing and polishing. This process took a several months to complete.

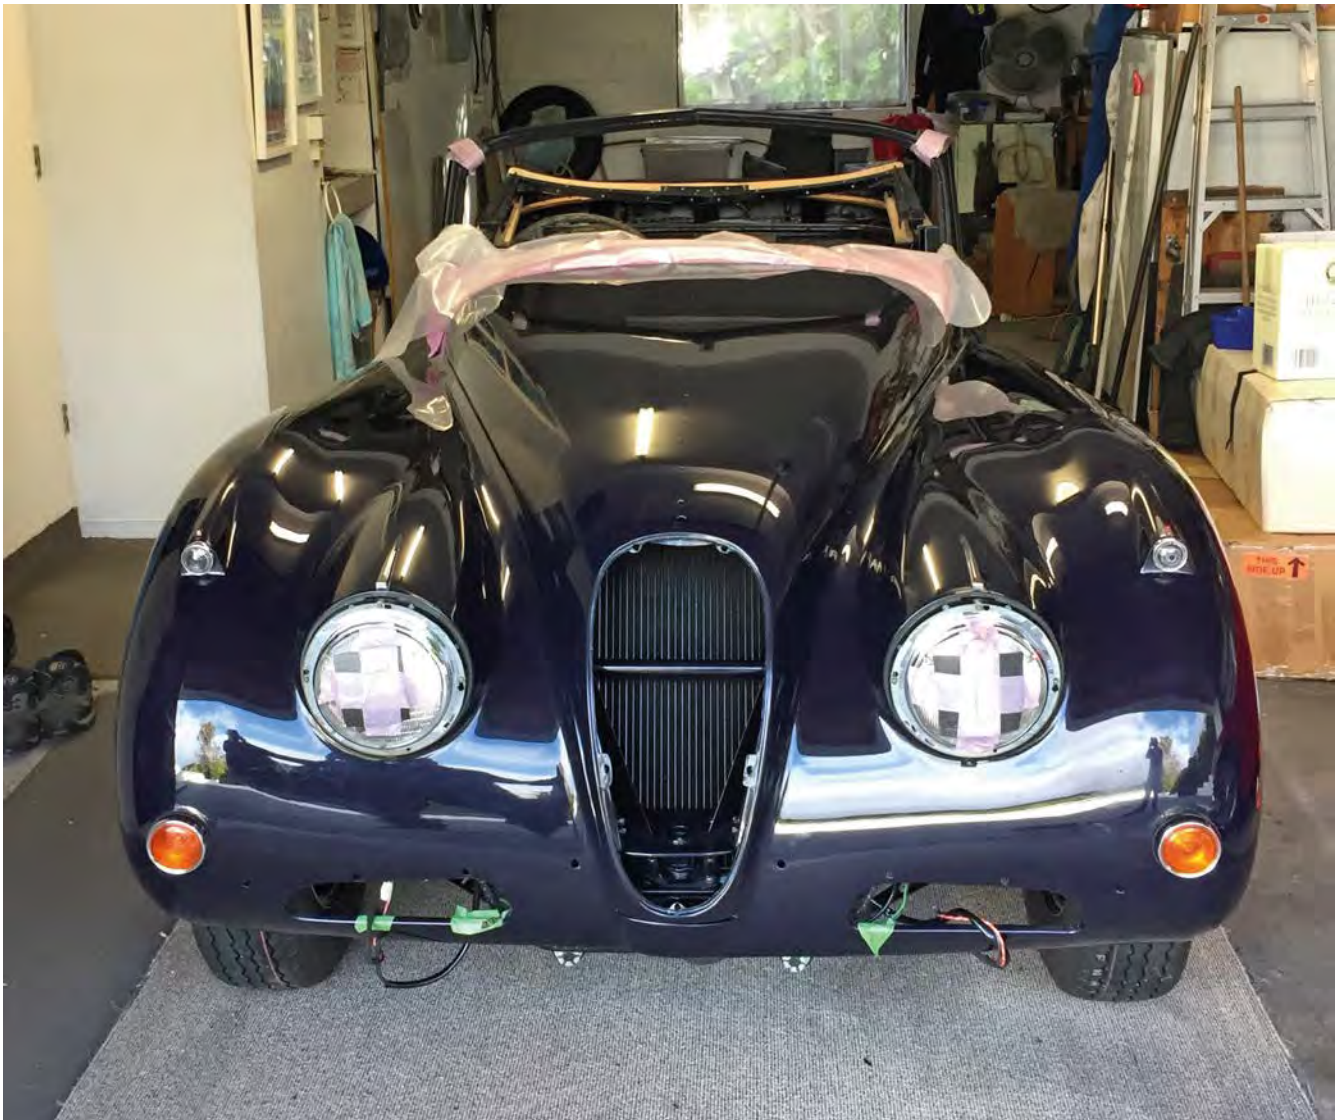
- Above: fitting-up begins after reuniting body and chassis. Two attempts were needed to get the correct blue

then, wham, Covid lockdowns threw a spanner in the works. I had ordered the exterior topcoat paint and delivered it to the body/paint shop prior to lockdown. However, when the painted car was delivered back to our home there was a *big whoops* moment. The colour shade was wrong. So back it went for a full sand back and repaint in the correct shade of Pacific Blue.

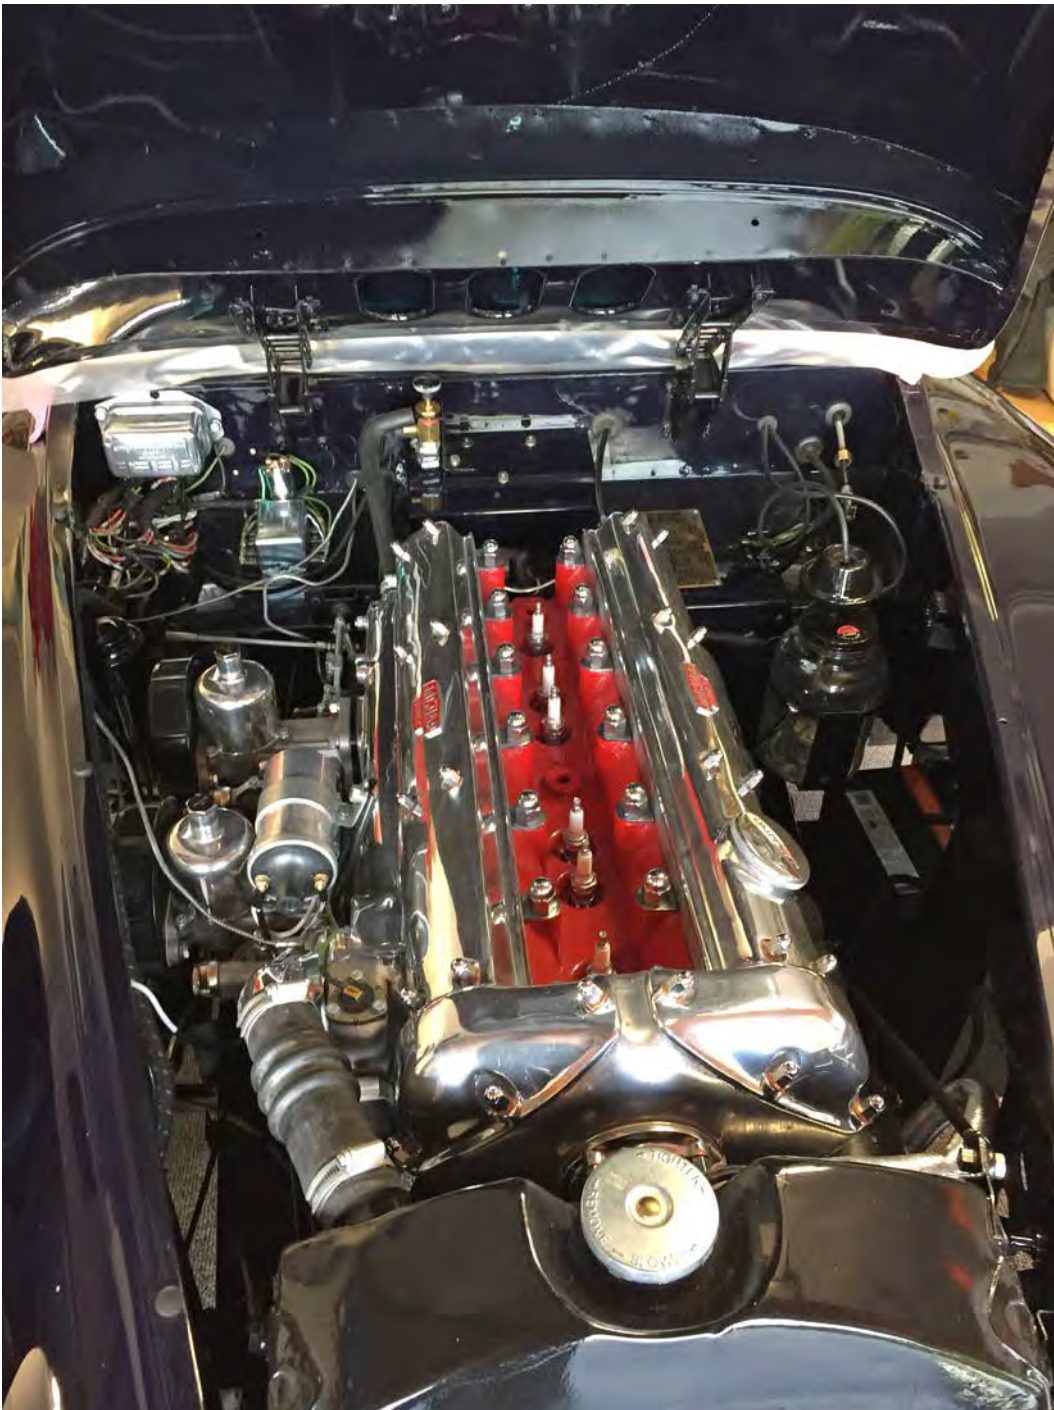
- Left: the gleaming engine bay. This particular unit retains its original block and cylinder head

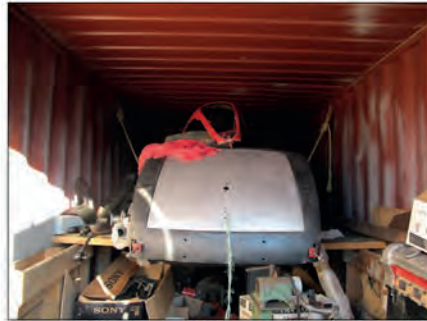
May 2017

- Right: how it started and how it is now – the 140 pictured in its shipping container and at the completion of the rebuild just under four years later
