XK 150S FHC Restoration

Closing a chapter to start the next by Tom Wright

Part 2: Great News! by Tom Wright

Part 3: Bad News! The block is cracked... by Tom Wright

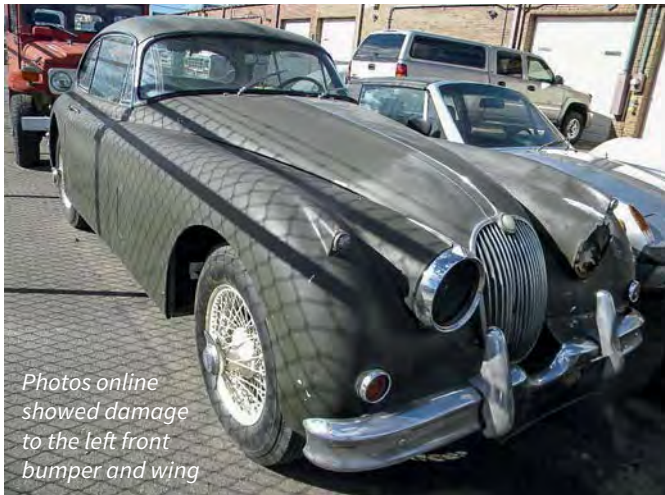
Photos online
showed damage
to the left front
bumper and wing

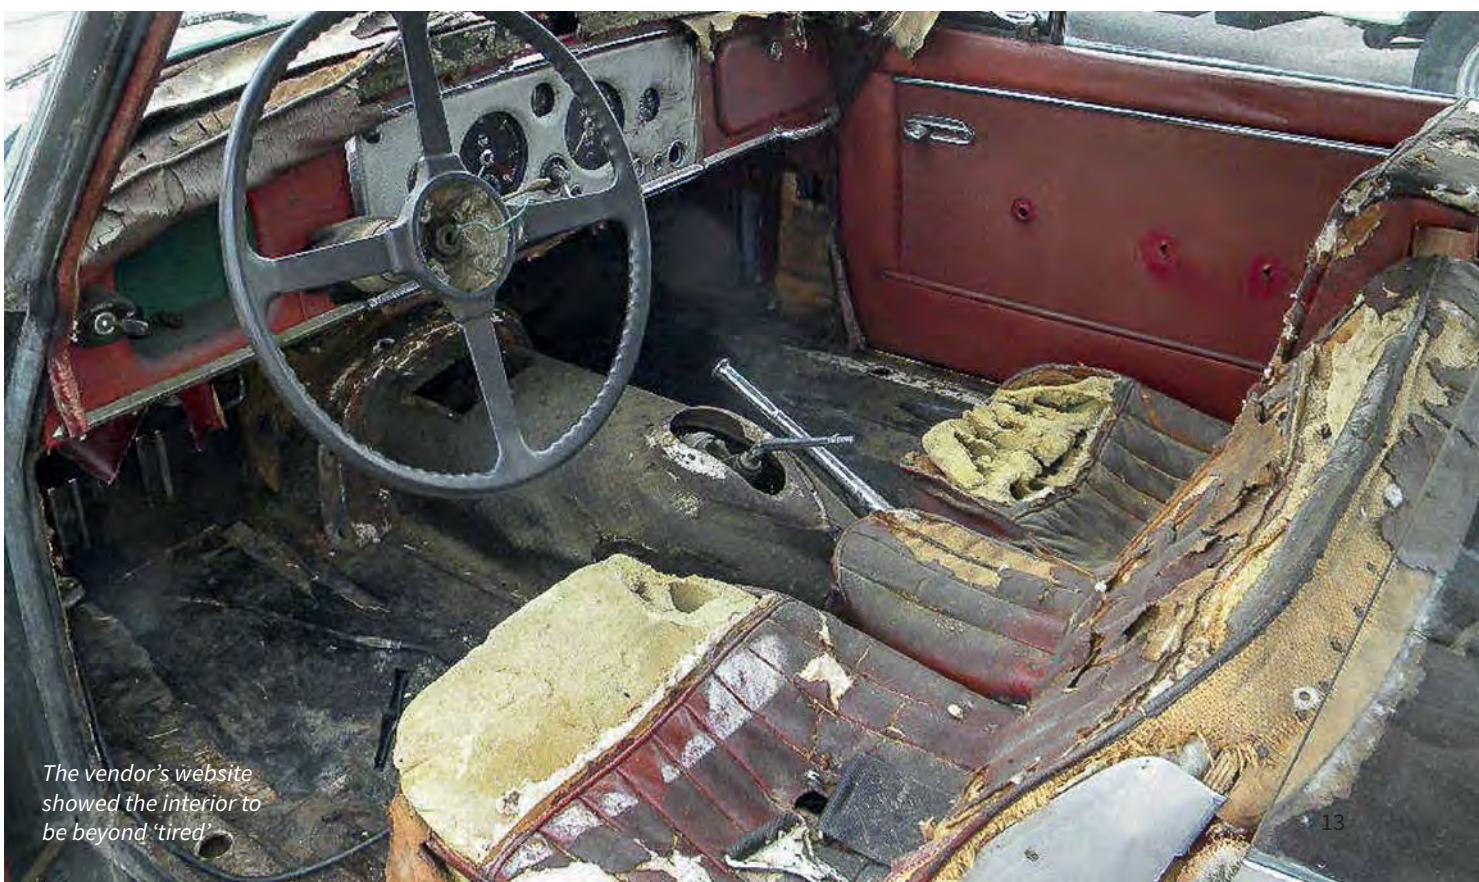
The vendor's website
showed the interior to
be beyond 'tired'

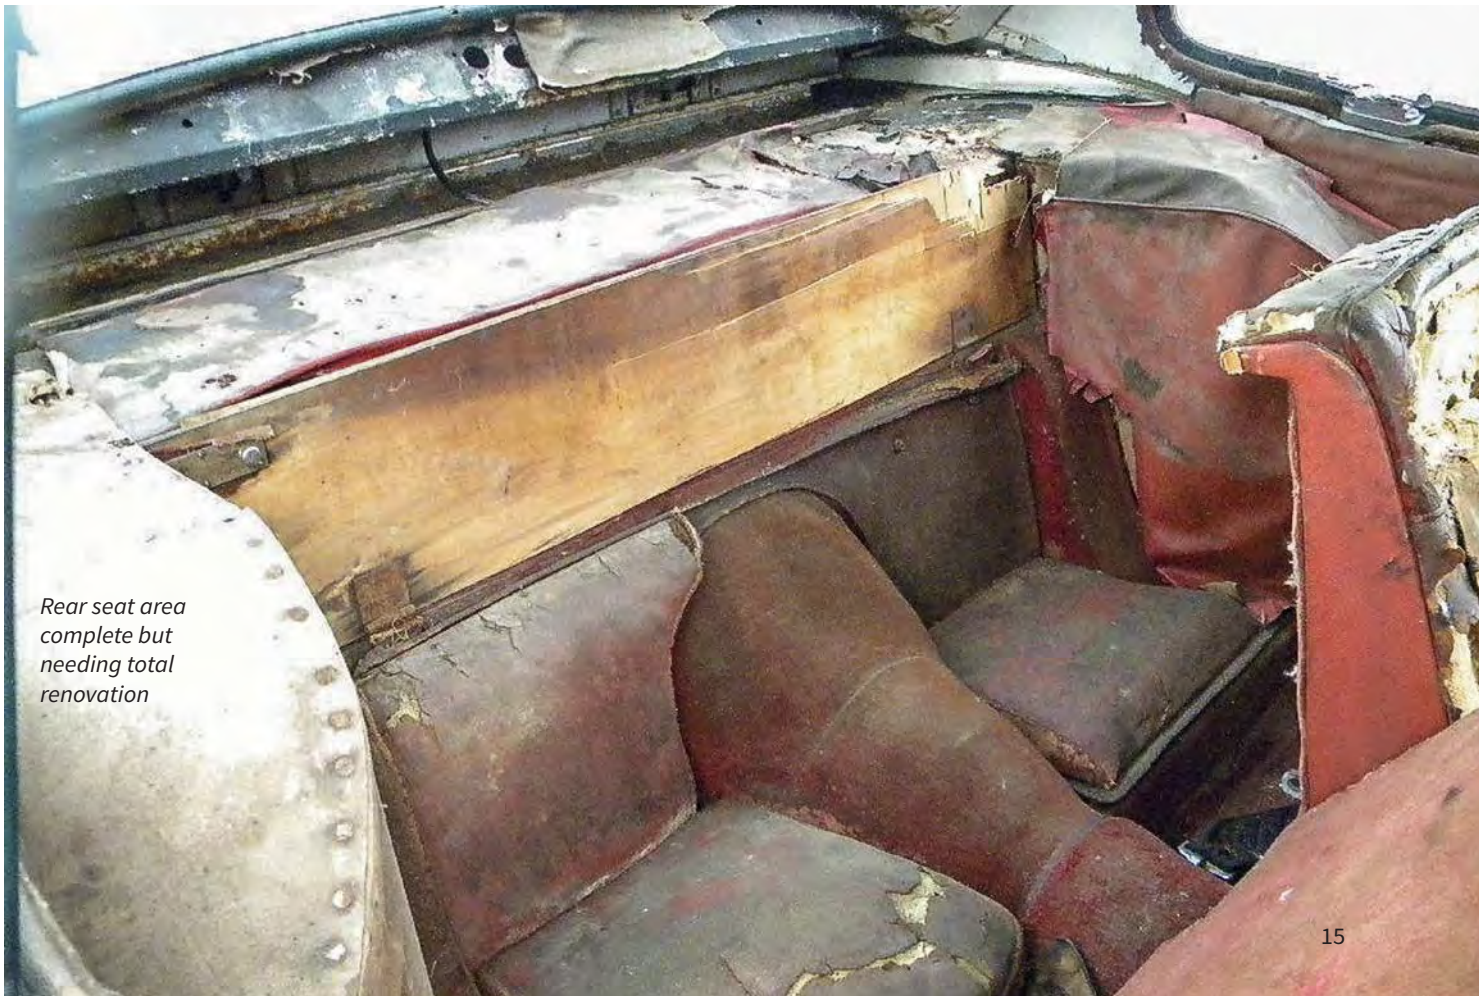
Rear seat area complete but needing total renovation

Spare wheel still in place in the boot

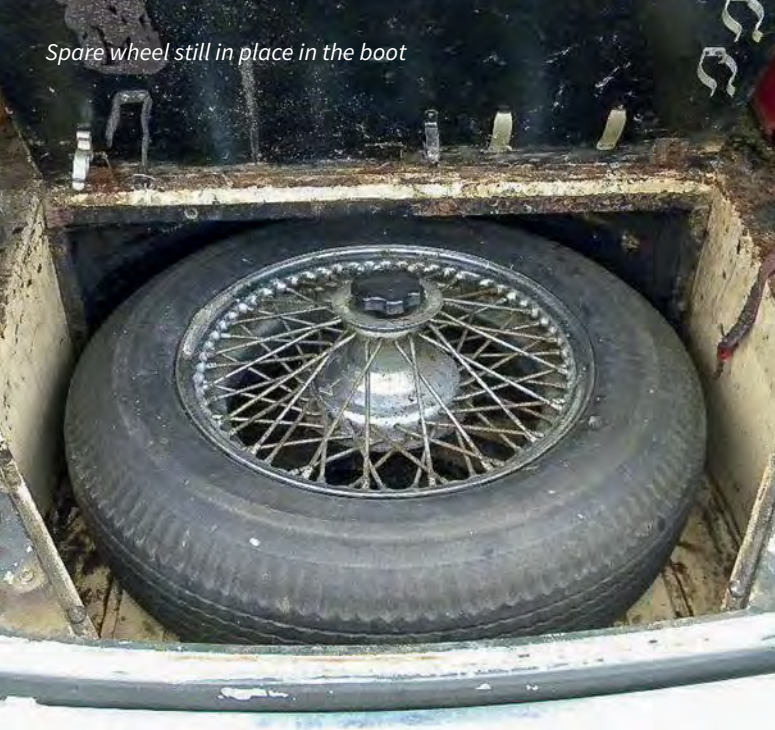
Removing the spare revealed a very sound boot floor

The spare tire well was taken out, allowing for the removal of the gas tank. As could be seen in the photos, the well had no rust, only accumulated dirt and crud. The rust in the battery boxes was limited to their floors. The floors will be replaced with new steel in a size to allow sufficient room for a single 12 volt battery on the passenger side that will replace the original two six volt batteries. Vacated rodent nests were found in the lower cowl area. The blaster's work will eliminate any residual rodent smell. Minor rust areas resulting from the nests are easily repairable.

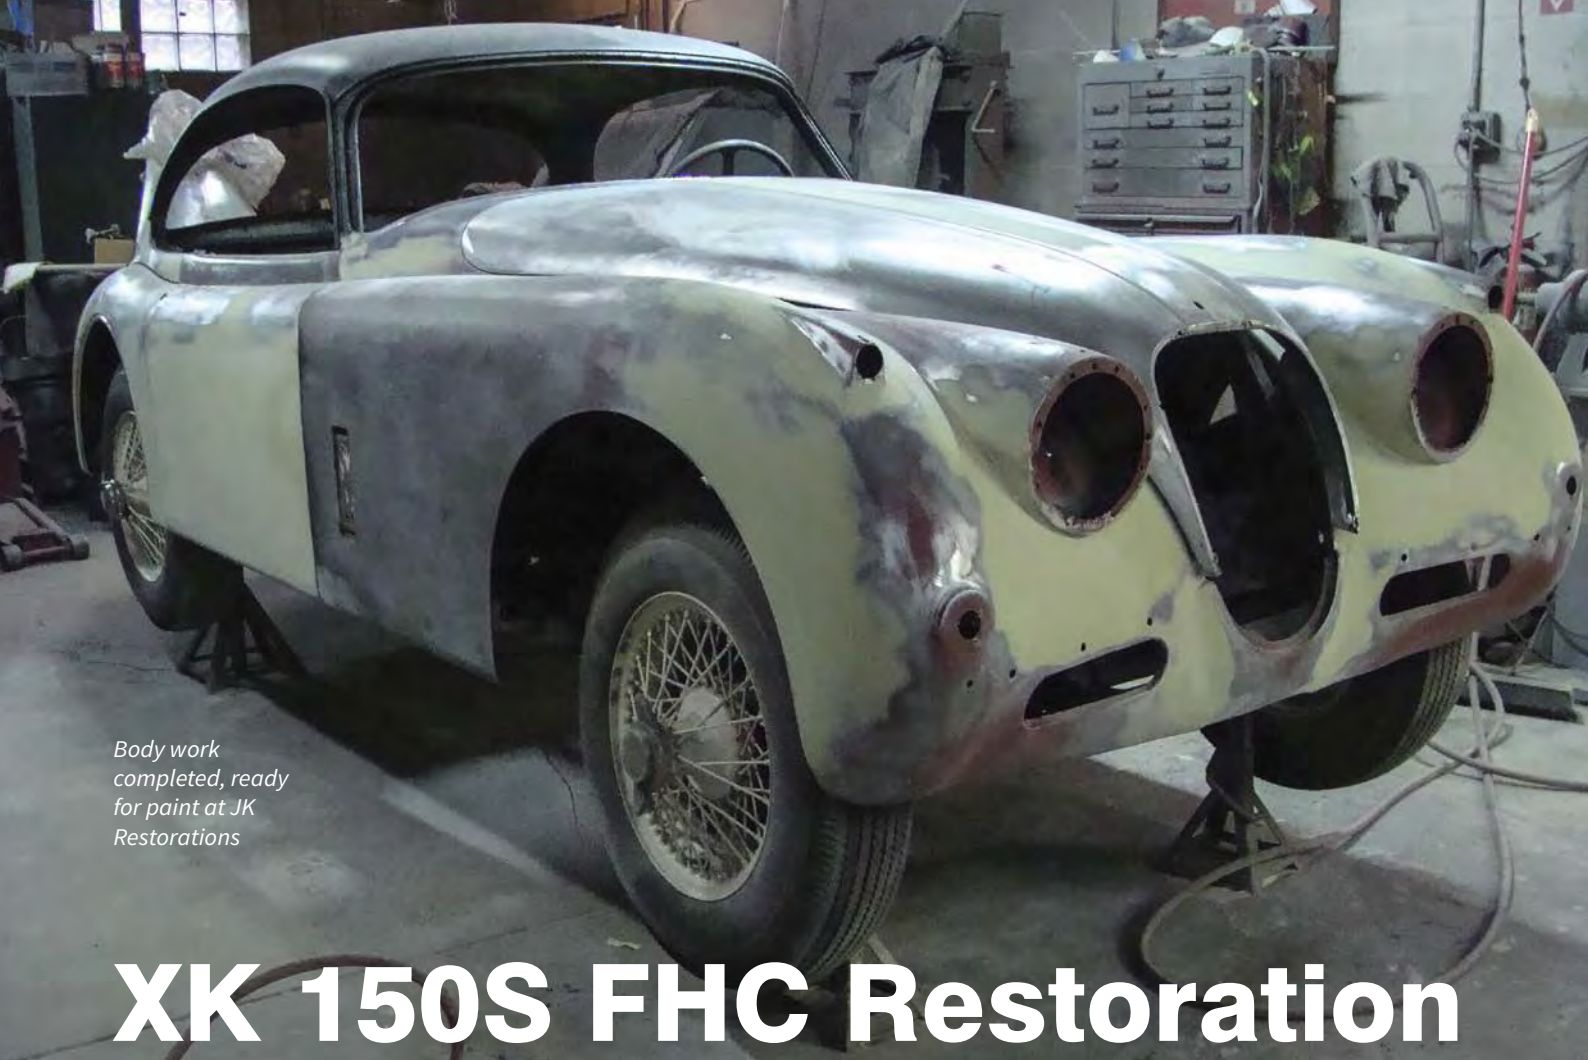
Body work
completed, ready
for paint at JK
Restorations

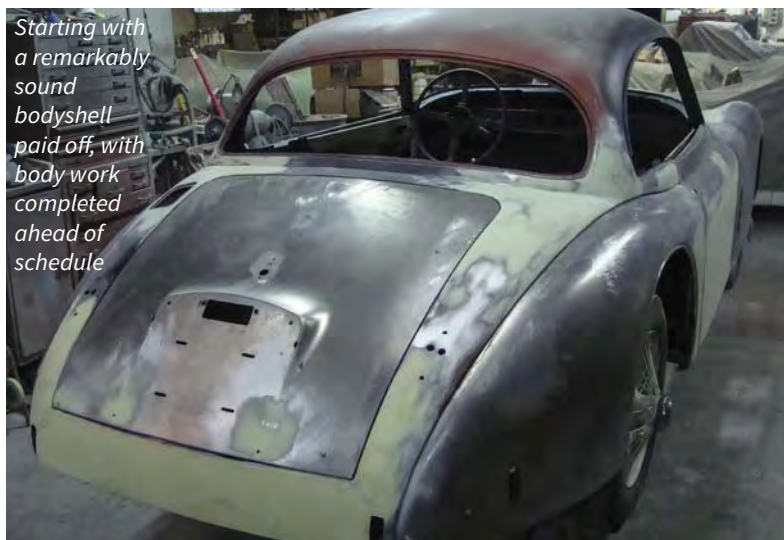
Starting with
a remarkably
sound
bodyshell
paid off, with
body work
completed
ahead of
schedule

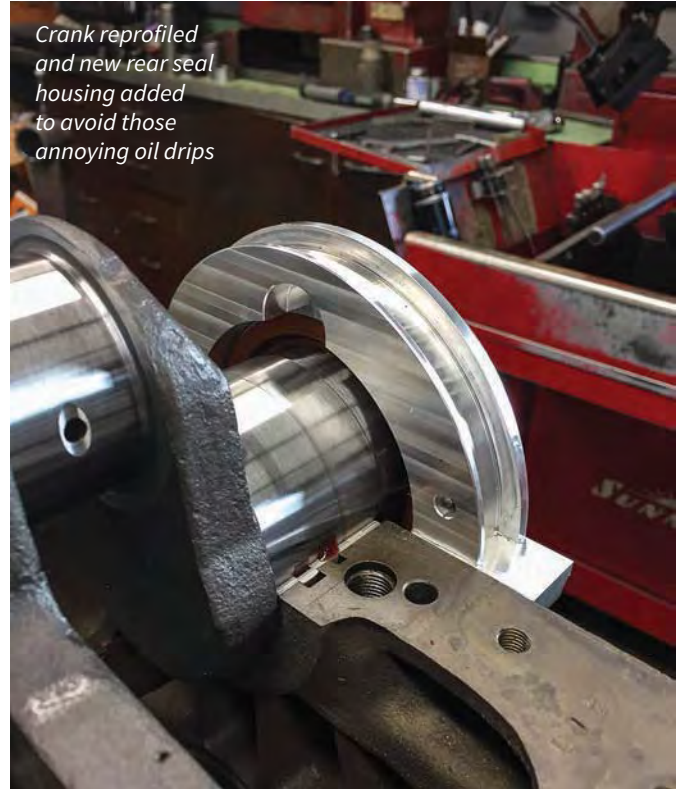
Engine build-up commences at Auto Machine Inc

When changing from 3.4-liter blocks to 3.8-liter blocks, Jaguar fitted liners in the cylinders to protect the water jackets. Liners of our 3.8-liter replacement block were removed and new ones installed. Major internals from our original 3.4-liter block – crankshaft, rods and oil pump – were reconditioned and reused, as was the oil pan and pickup which are unique to ‘S’ models. To ensure thorough cleaning of the oil pan, its inside baffles were removed and then spot-welded back in place when cleaning was completed.

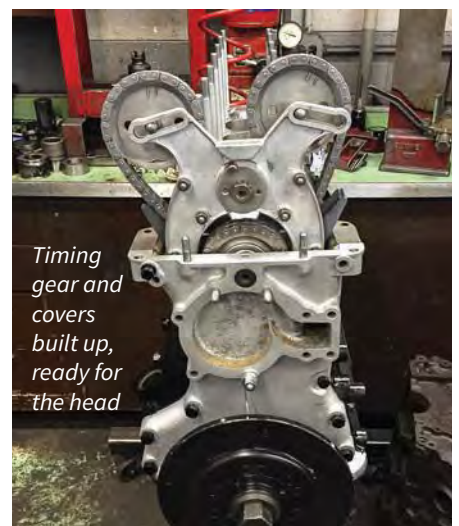
Timing gear and covers built up, ready for the head

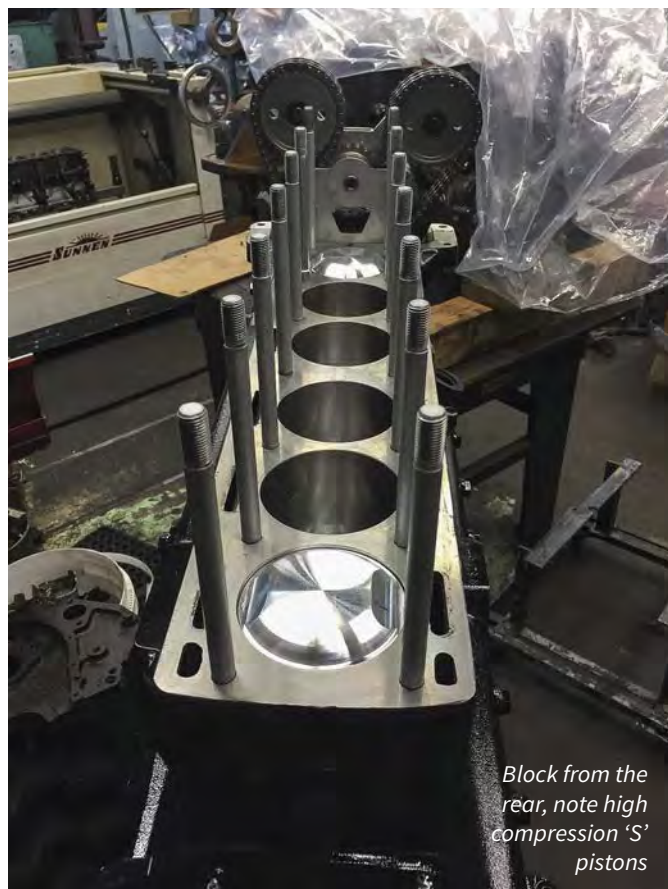
Block from the rear, note high compression 'S' pistons

New Arias pistons, forged rather than cast, were installed, together with Total Seal rings. The stock crankshaft relies on a reverse spiral machined into the rear of the shaft to aid oil sealing, which often results in an infamous Jaguar characteristic: oil leaks. Auto Machine installed a conversion kit, which requires machine work on the crankshaft, to hold a modern rear seal in place. The XK 150 stock neoprene front seal (much improved over the rope seal used in earlier XK engines) is adequate and a new one was installed. Oil leaks through the seals may not be totally eliminated, but they will be minimized. The harmonic balancer was rebuilt. New valve guides, valves, springs, and camshafts were installed in the head

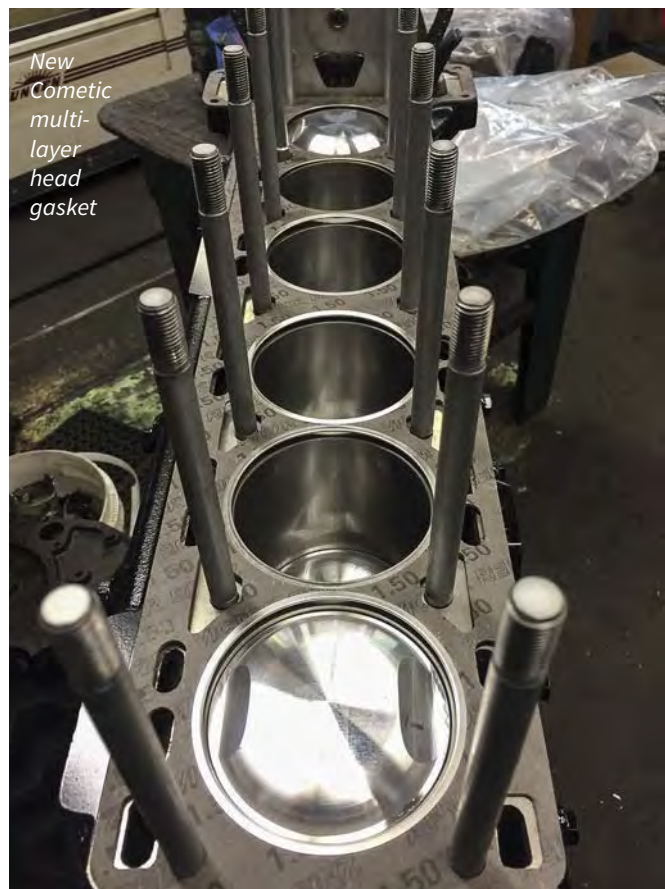
New Cometic multi-layer head gasket

(VS 1787-9) as were tappet hold-down kits on both sides. The head was installed using a Cometic multi-layer steel head gasket.

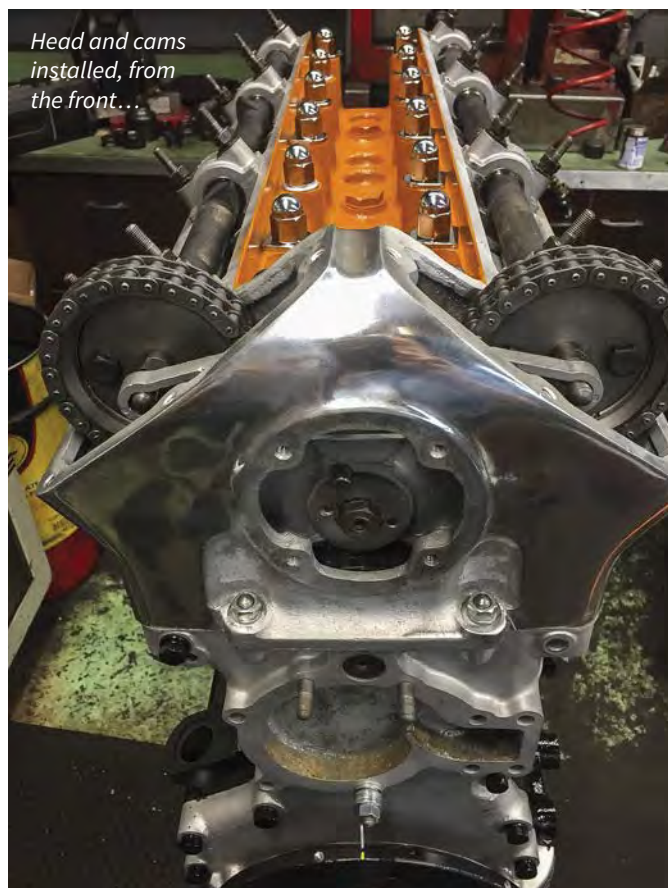
Head and cams installed, from the front...

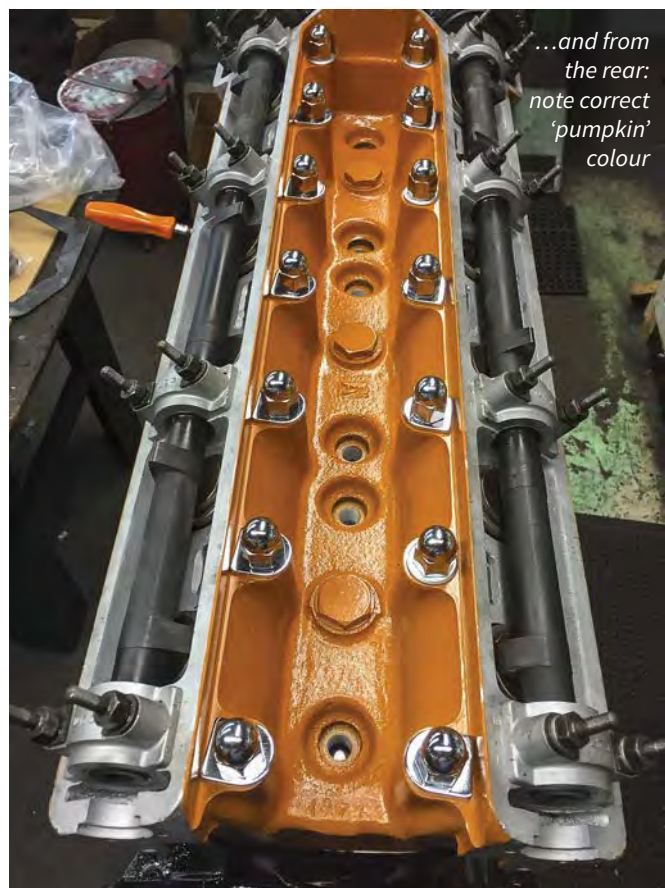
...and from the rear: note correct 'pumpkin' colour

The heads of both XK 150S and Series I E-types were painted in a color that Jaguar termed “Old Gold”. A problem that has plagued many restorers is that there are two distinctly different Old Gold colors, depending on the model in question. XK 150S heads were painted an orange color described as ‘pumpkin’. E-type heads subsequent to Engine No R2512 were painted in a light gold color. Photos from the machine shop of our XK 150S head show it to be painted in the correct pumpkin version of Old Gold.
