'They're all like that, sir'

Roger King uncovers more surprises in his latest XK 140 update – some of which were courtesy of Jaguar itself

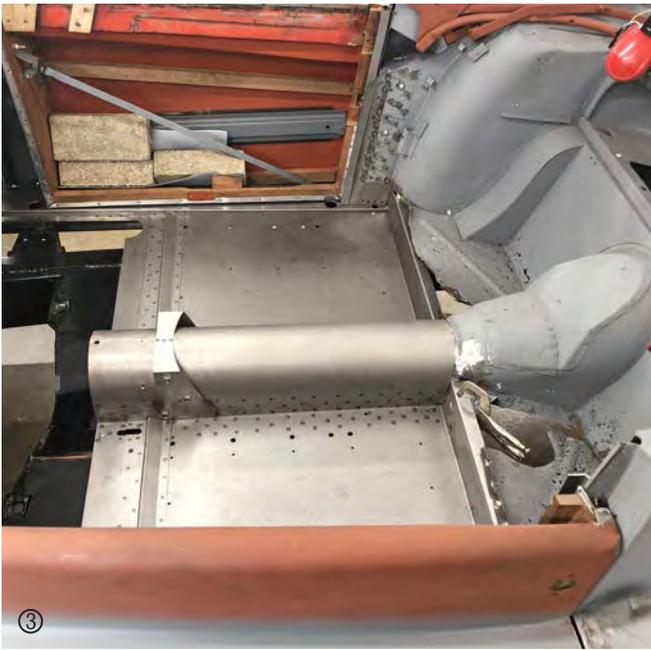
②

With the doors suitably weighted, I was now pretty happy with the general alignment (photo two). Now to get the floor sorted.

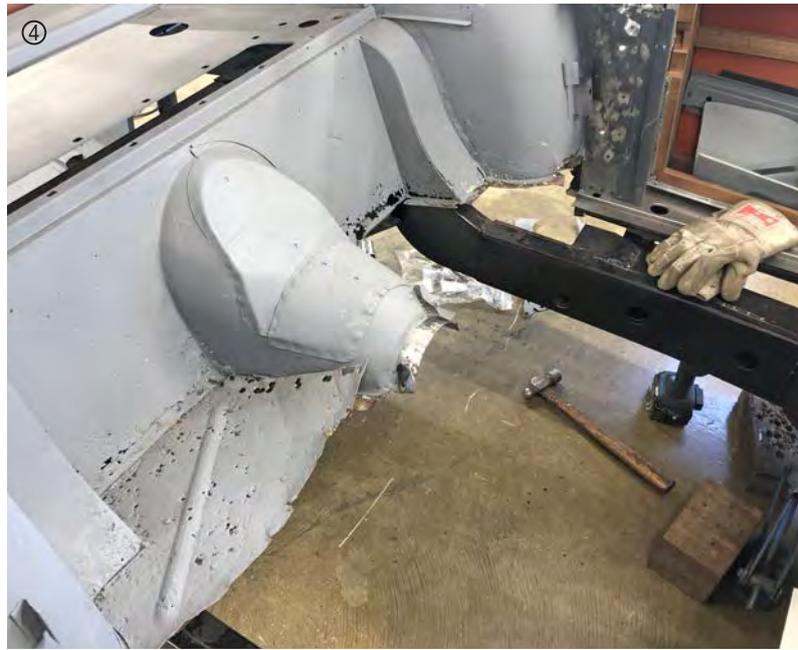
Time to come clean. Here, with the floor (photo three), I had effectively cheated – I bought a complete floor panel

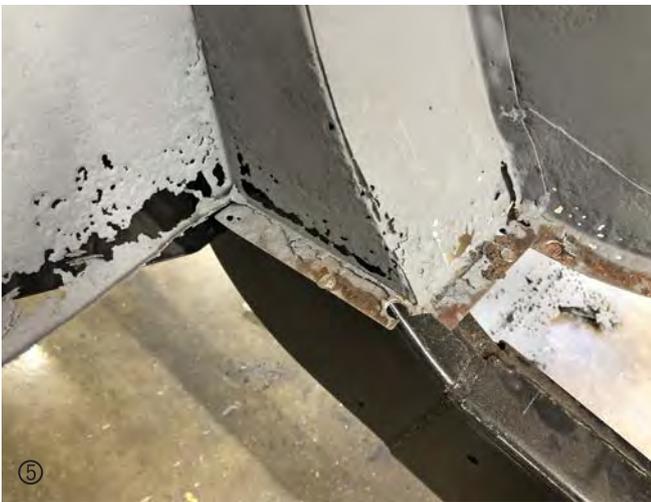
spot-weld cutter and the cold chisel again. The left side was the worst, so that went first – see photo four.

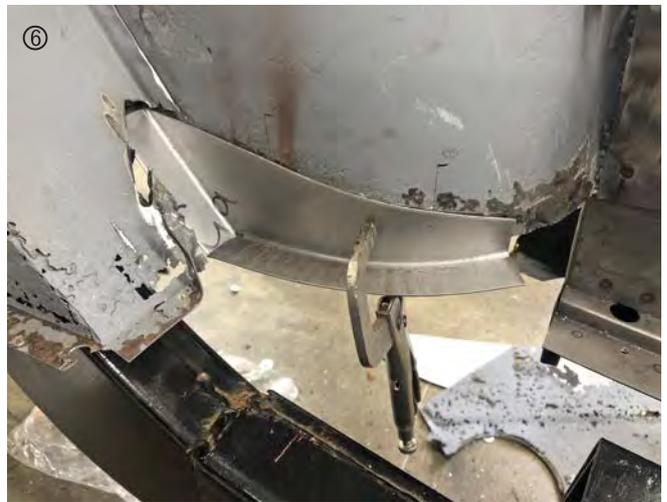
The metal around here was like lace in places, as can be seen in photo five. When it gets like this, wholesale replacement is the only answer. When you see a report on any car for sale that includes the words 'a few little bubbles' regarding the body, this is what is lurking under the paint. A bubble means a hole, and a hole means new metal is needed.

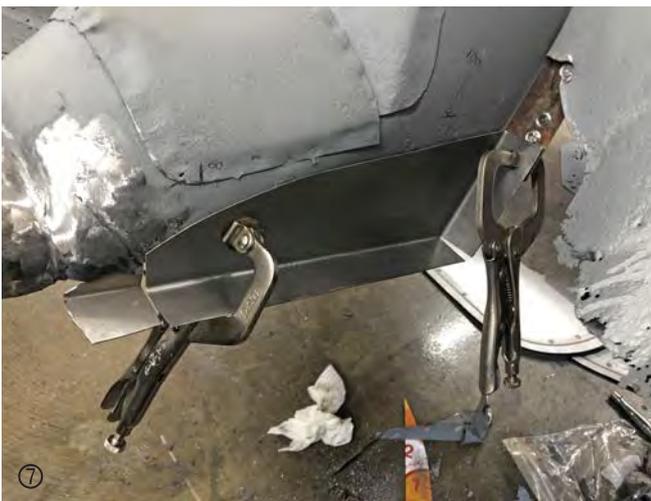
The first job was a repair patch in the wheelarch, shown in photo six. And then, repair patches for the left side of the rear transmission tunnel, as seen in photo seven. This is shown in photo eight, welded in position but not finished. Note a new seat pan, a pretty simple panel made using measurements from the remains of the old one, is used for an alignment check.

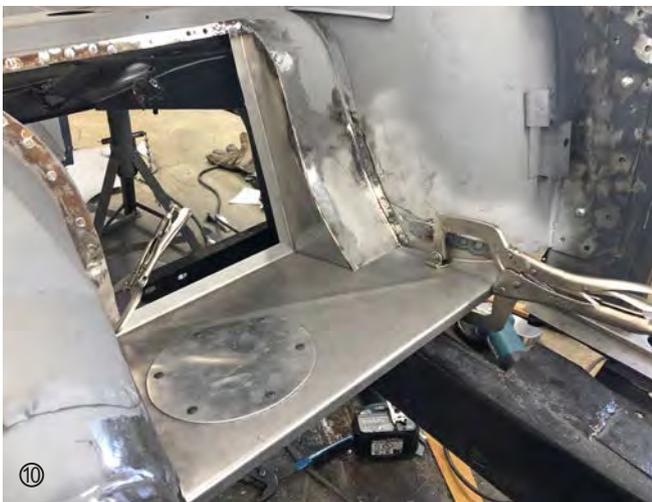
Next, a new side panel for the seat side (photo nine) and the chassis riser box were finished off, shown in photo 10. The rear section is now starting to look a lot better. You know, it's definitely quicker to type about doing this rather than actually doing it...

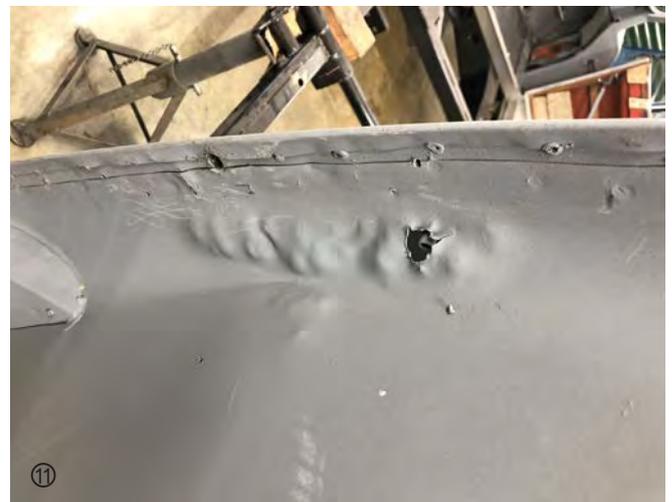
One interesting discovery was made during this part of the job. The blasting and grey primer served to draw attention to some serious butchery in the rear inner wheelarch around the fuel filler box. With the wing off, this was easy to see (photo 11). What idiot had been let loose on my car, and why?

As photo 11 reveals, the top of the inner wing has a longish row of ball hammer blows, with a hole punched using a cold chisel at the rear. Research at the JDHT, and chatting with various professional restorers, revealed that

this abandonment of sophistication is, believe it or not, factory correct. This is how the guy on the production line made space for the filler box to fit, and the hole is how he established a vent for overflow when filling. Now, there's British craftsmanship for you! That said, some years ago I inspected an Italian-bodied De Tomaso Pantera I was considering buying, and the internal metalwork on that made the XK look like Michelangelo's next job after sculpting David, albeit a little less revealing.
