## Bump up the volume

**Ewan Pearson** documents the subtle changes that took place in XK 150 bumpers during the model's production run

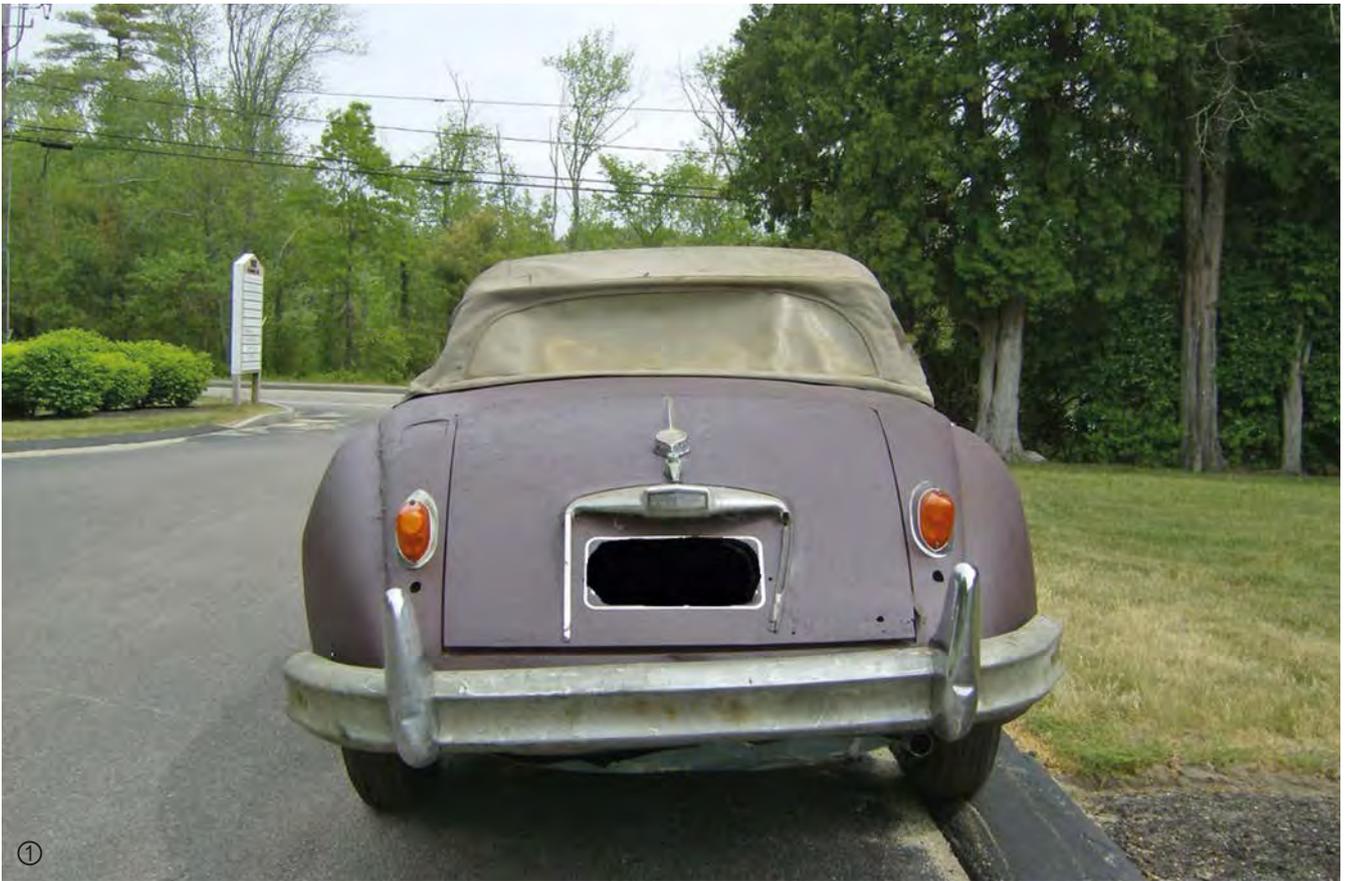
Firstly, I must confess that I don't find bumpers and over-riders very interesting, so this is a bumper article not a bumper article – geddit? But I do want to reciprocate to all those authors whose helpful articles I have read, and our membership, if I can. I had to get a bit involved with my bumpers because I am interested in accuracy, and when my latest (second) XK 150 arrived from New York in July 2015, pretty much as a rust-bucket plus boxes of bits, I soon found that I had a load of the wrong parts. But at least I got two rather rusty bumpers with over-riders, with all three bits on the rear one dented, as well as leaning out in a 'man-splaying' fashion. See photo one.

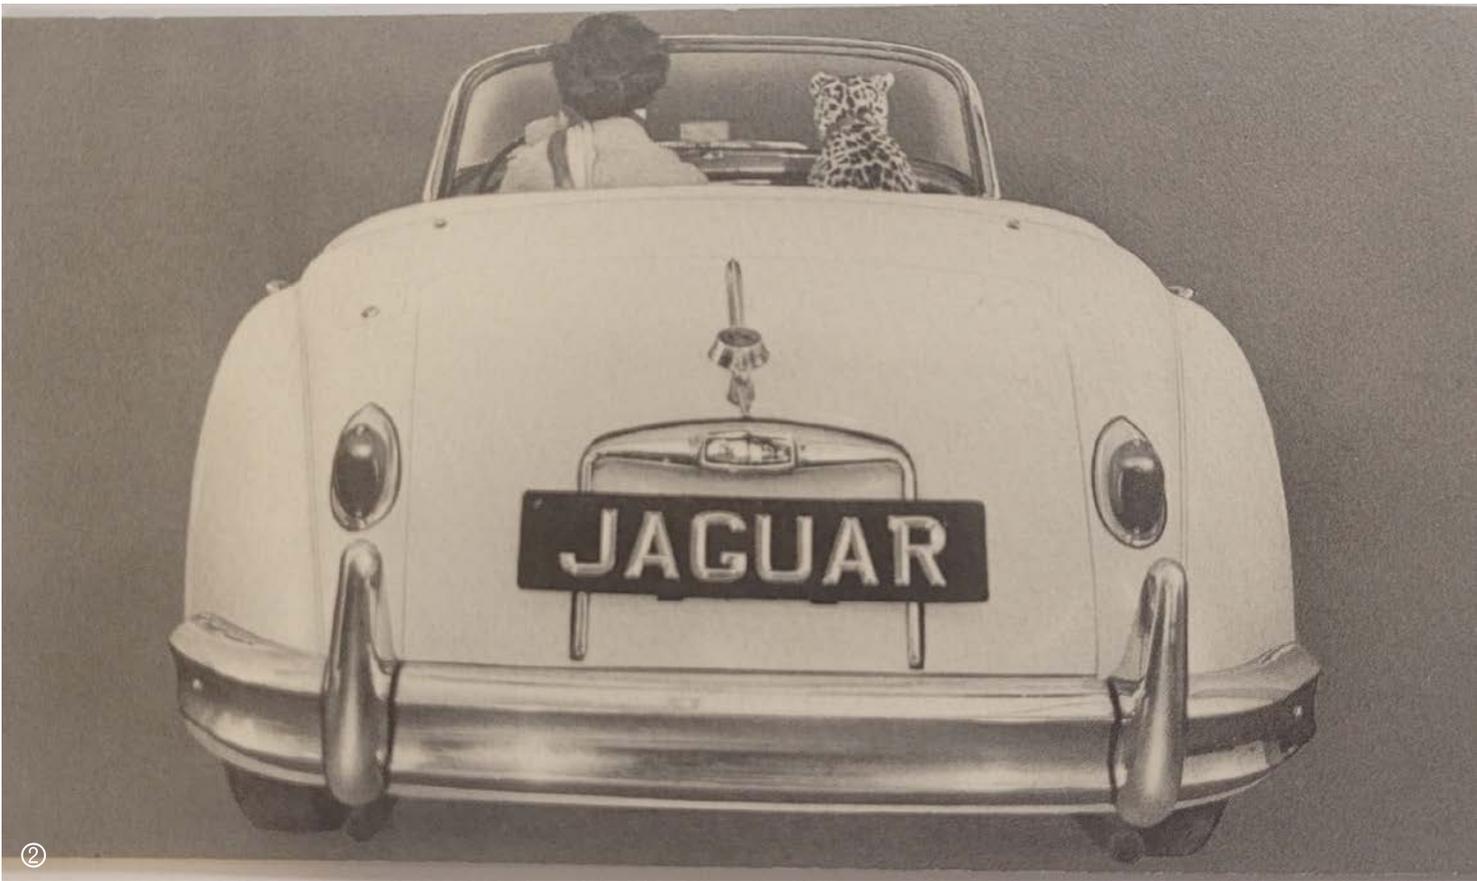
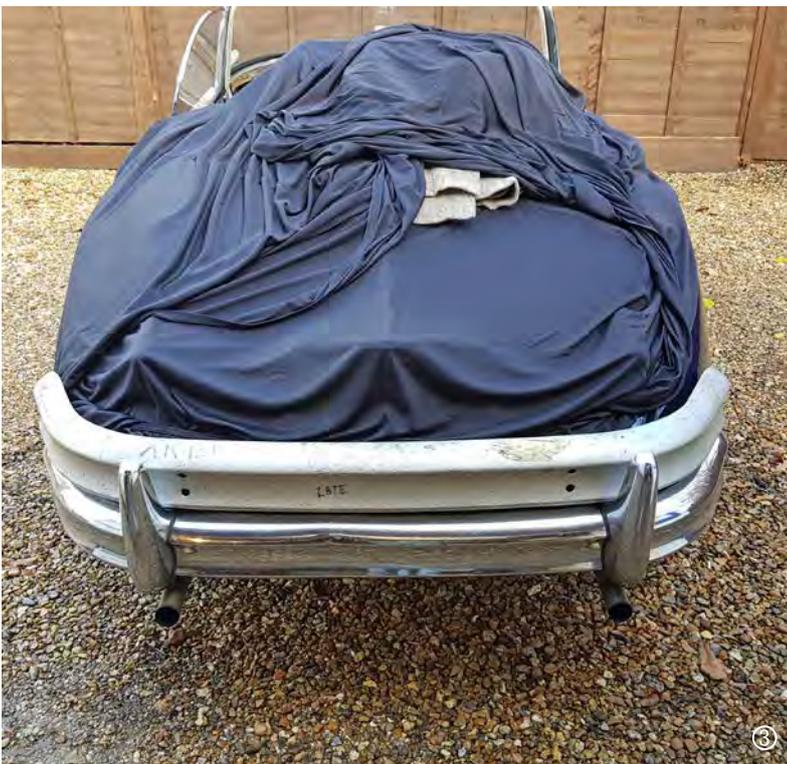
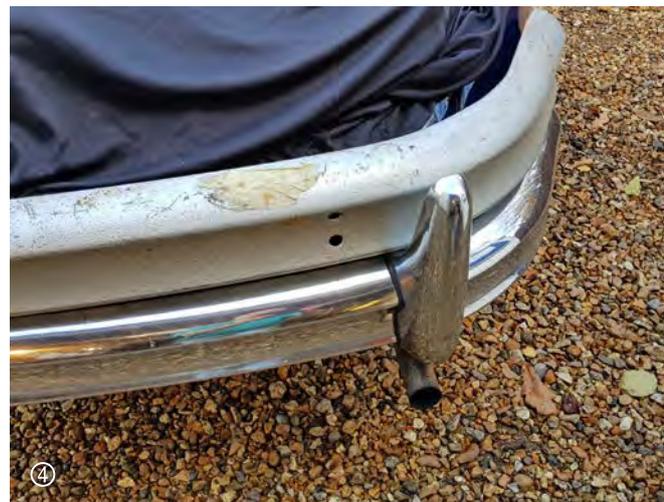
I suspect they were all made in the same press but then altered as the two changes came through.

The difference in the rears is determined by the angles at which the three variants bolt on. This required different cut-aways on the side nearest to the centre of the cars, and thus different angles for the welded-in mounting plate. As a result, the rubber beading on the two edges slightly differed in length – ah, that’s why! That said, the lengths specified, at 5½in for the inner and 6½in for the outer edge, give an excessive difference probably inherited from the XK 140. You just cut off the excess after fitting.

From September 1958 the XK 150 changed to an ‘interim’ version with the over-rider moving in towards the centre by 3in on each side. This was after some 3,460 cars had been produced, well ahead of the new rear lights being fitted. You can see the difference in the holes in these pictures of my car (photos three to five). The modification to the bumpers would have been simple, only moving each of the four drill holes towards the centre before being chromed, but the over-riders were now on the less-curved part of the bumper, so they also had to change, very subtly, and that meant a tiny change to the angle of cut-aways and the welded plates. The change is so slight to the cut-aways on the sides that I doubt most people would see the difference, but the part numbers changed (see table one), conclusively showing they had been modified.

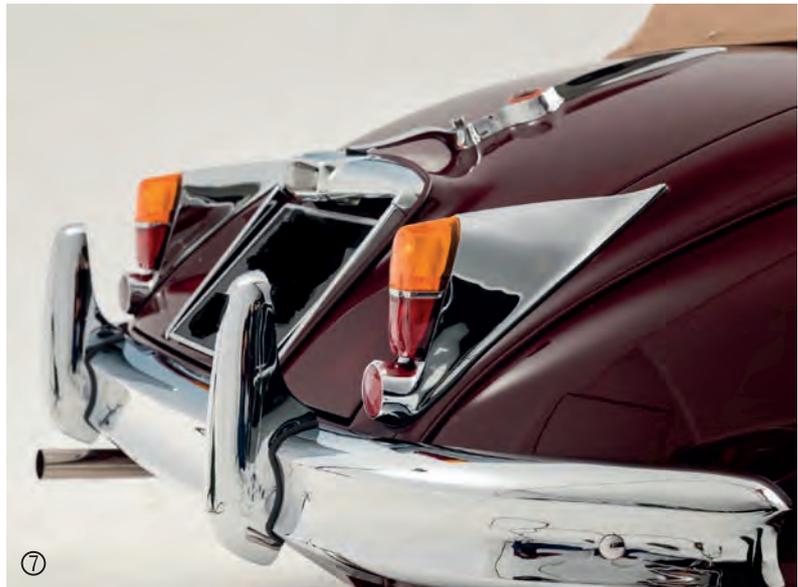
Jaguar changed the rear light cluster in October 1959, over a year after the bumper change had been implemented. The revised bumper arrangement was already suitable, so was able to continue. Hence there are two key change dates, September 1958 and October 1959. Photos six and seven show the third and final configuration.
