# Restoring an **old friend** part one

**Jerry Watson** starts a three-part series covering the rebuild of an XK 150 that he's known since childhood

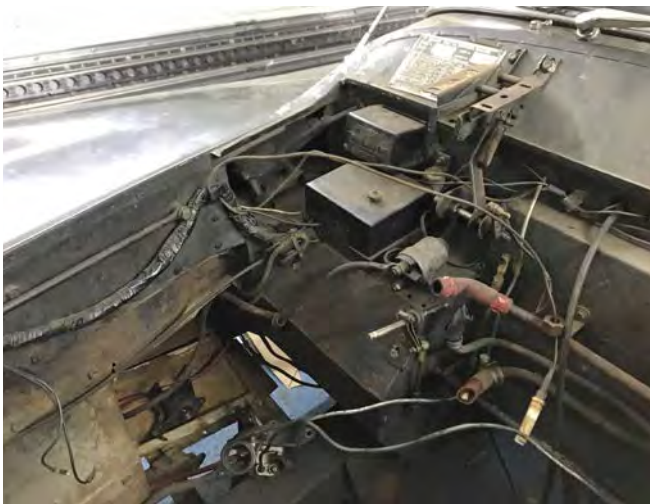
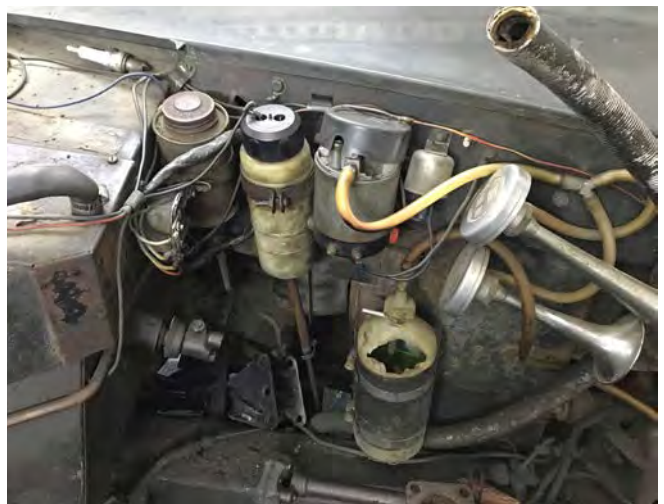
- Left: the XK as it is today and (right) as it arrived. Pictured below left is the car's Heritage Certificate
- Below left and right: with the engine having been removed, the next job was to strip down the engine bay

While the engine was out we were able to thoroughly inspect the chassis and all the inner wing areas, including the battery boxes. To our delight, the chassis was in incredible condition and we had to make the decision about removing the body or leaving it on.

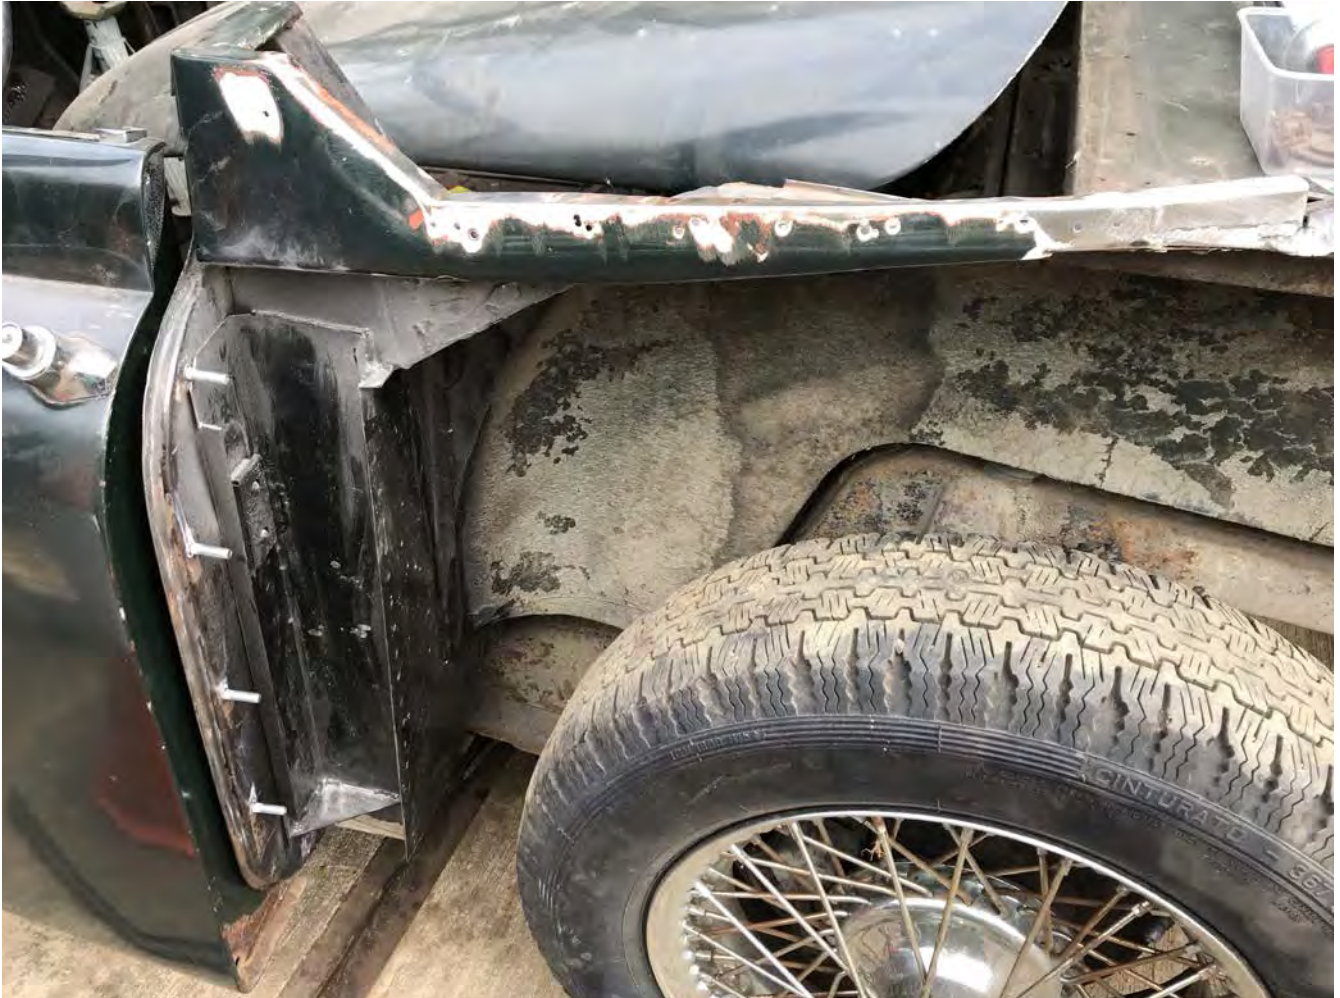
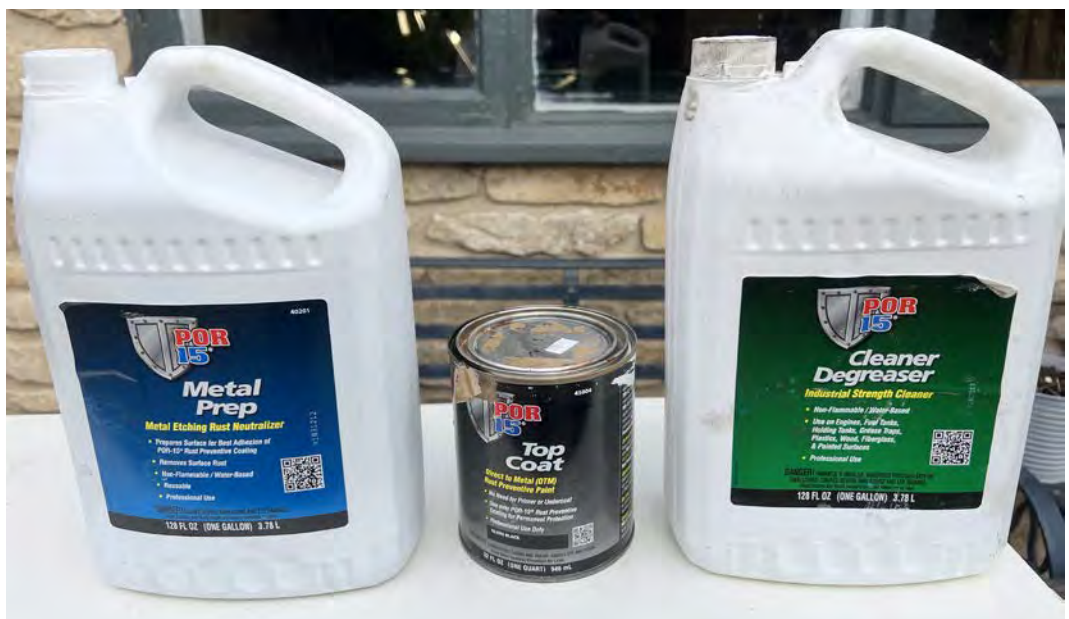
- Top left: two more shots of the engine bay. The order of the day was to refurbish rather than replace where possible
- Left: cleaning the rear axle and other components
- Right: Jerry was impressed with the POR-15 system. Above is a photo of the underside before it was applied...

We repainted the chassis using the POR-15 paint system. I had seen reports on it and I must say I am incredibly impressed. It is a bit more complicated to apply than other systems and is certainly more expensive, but the results are spectacular. Other suspension parts we painted with this look like they have been powder-coated, and you can really hit it without it chipping off.

However, the downside is it's really a four-stage system. First you use the degreaser and wash that off, then you use an acid primer liquid and wash that off and dry the surface, then you apply the paint. If the area is not subject to sunlight you can leave it at that, but if it is, you need to use the additional top coat to retain the shiny black appearance. 🏆

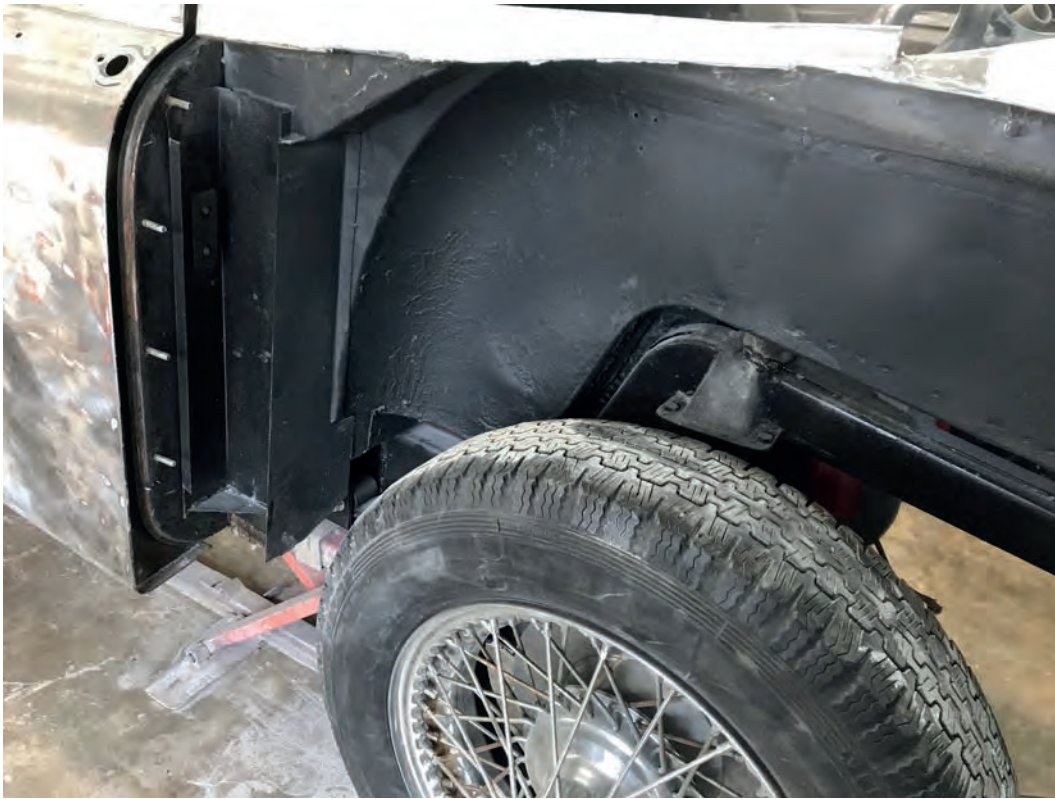
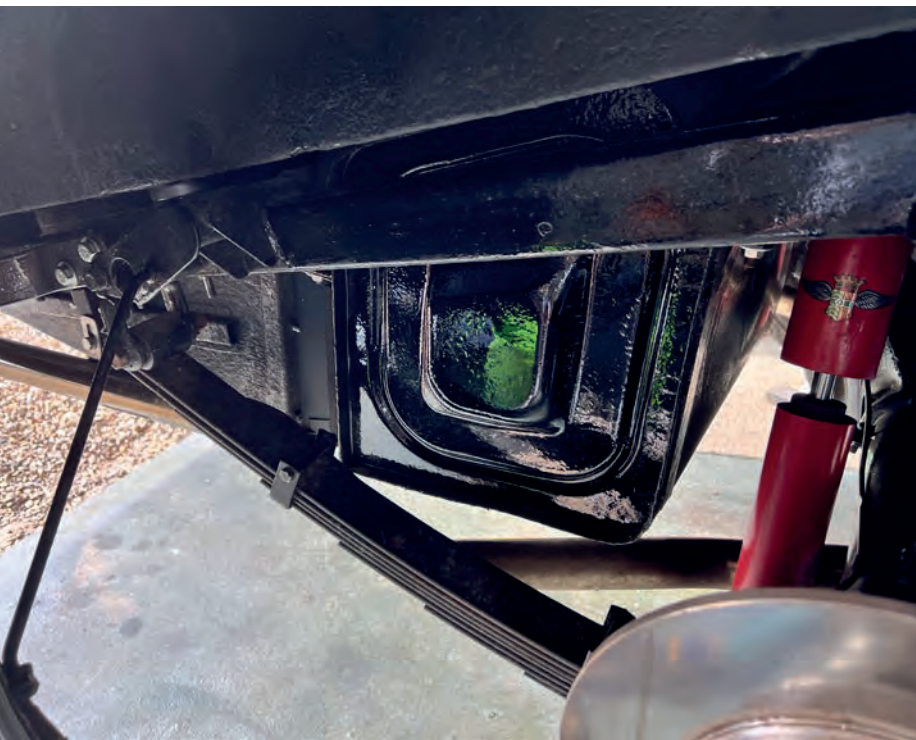
- Left and below: POR-15 applied. The underside of the car was thankfully in surprisingly good condition, although a cracked rear spring was discovered during the disassembly process

The use of the outside lift was invaluable because the steam-cleaning and chassis paint removal was a filthy job. While we were cleaning the chassis at the rear of the car, we discovered a broken spring, so we removed the springs and the axle. Inspection of the axle showed the limited-slip differential to require a rebuild. Project Heaven did this for us and replaced the bearings and seals of the axle.
